PROPOSAL NAME: Fastview Corporate Plaza

DETERMINATION OF NON-SIGNIFICANCE

The applicant has requested a Critical Areas Land Use Permit review of a proposal to construct a 40-space surface parking lot and block wall within a critical area steep slope and 75-foot steep slope structure setback. The proposed surface parking lot is located within the code required steep slope and steep slope structure setback, and requests allowance of permanent modification 1,280 square feet of the steep slope and disturbance of an additional 2,050 square feet of the steep slope. The proposal includes approximately 4,345 square feet of steep slope mitigation, restoration, and enhancement planting to improve degraded slope. See Figure 1 for proposed site conditions.

Eastview Corporate Plaza Accessory Parking Lot

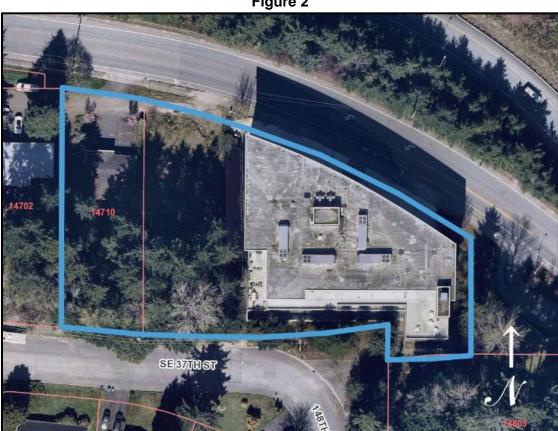
64,090 square feet in size; and is currently developed with a 4-story office building and a 1-story single-family residence. A steep slope critical area with a north-facing aspect is located between the existing single-family residence and SE 37th St. The site contains a variety of native and non-native vegetation, including but not limited to Douglas-fir (*Pseudotsuga menziesii*), big-leaf maple (*Acer macrophyllum*), western redcedar (*Thuja plicata*), native and non-native shrubs, and invasive woody species. Lack of native vegetation coverage and location of existing single-family residential improvements have been identified within the steep slope structure setback, including the foundation of another single-family dwelling that has been demolished previously. The soil of this site has been identified as Arrents, Alderwood material (AmC) according to mapping provided by the Natural Resources Conservation Service (NRCS). See Figure 2 below for the current site.
